# **AN ASSESSMENT OF THE LAKES AND WATERSHEDS OF WEST MILFORD TOWNSHIP**

**TOWNSHIP OF WEST MILFORD, PASSAIC COUNTY, NEW JERSEY**

**JULY 2023; REVISED JANUARY 2024**

PRINCETON HYDRO, LLC  
PO BOX 3689  
TRENTON, NJ 08629

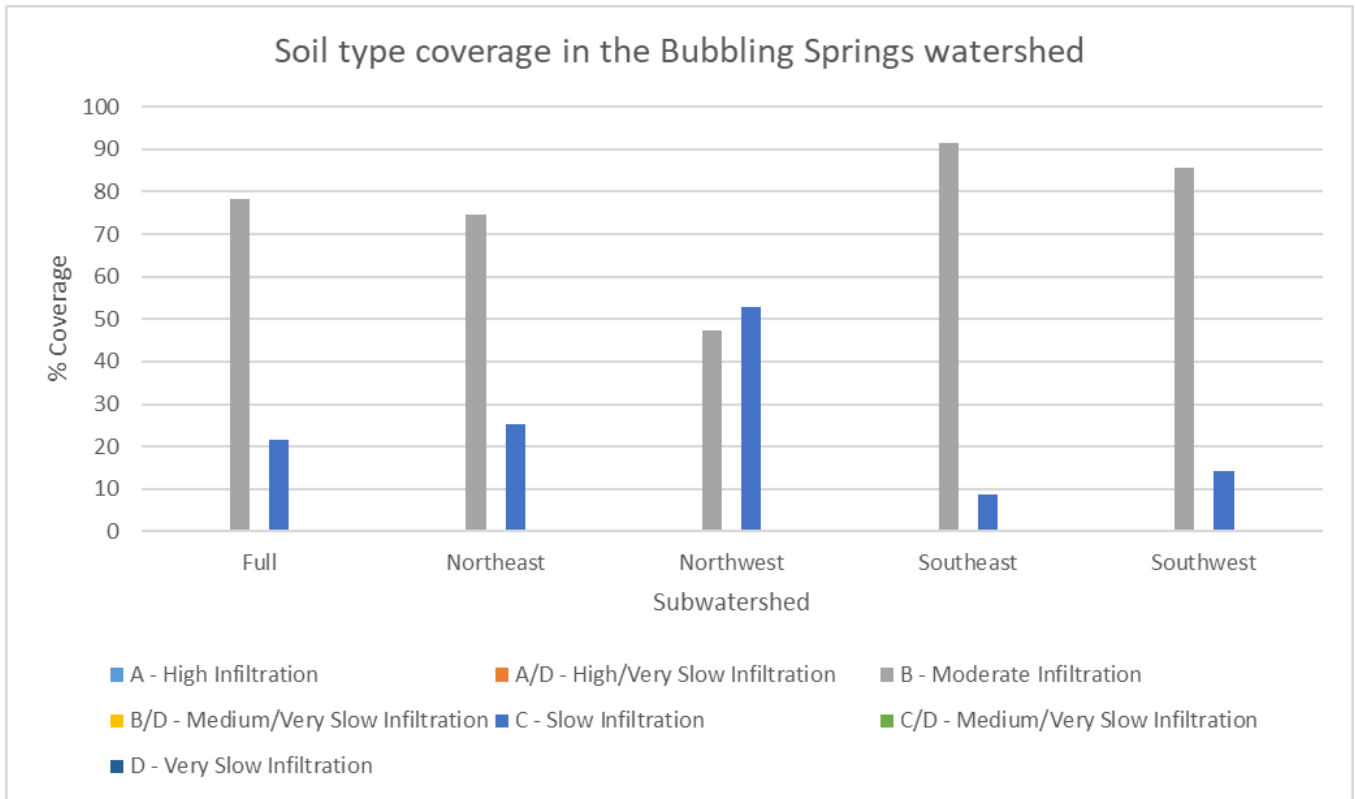
**Figure 6. Percent coverage of Bubbling Springs Pond’s Watershed and subwatersheds by different hydrologic soil groups**

Bubbling Springs Pond's watershed was modeled to largely contain soil group “B – Moderate Infiltration”, with approximately 20% of the area containing soil group “C – Slow Infiltration”. The Northwest subwatershed contained more than 50% coverage of soil group C. Areas with higher percentages of slower-infiltrating soil groups will generate greater amounts of runoff and erosion.

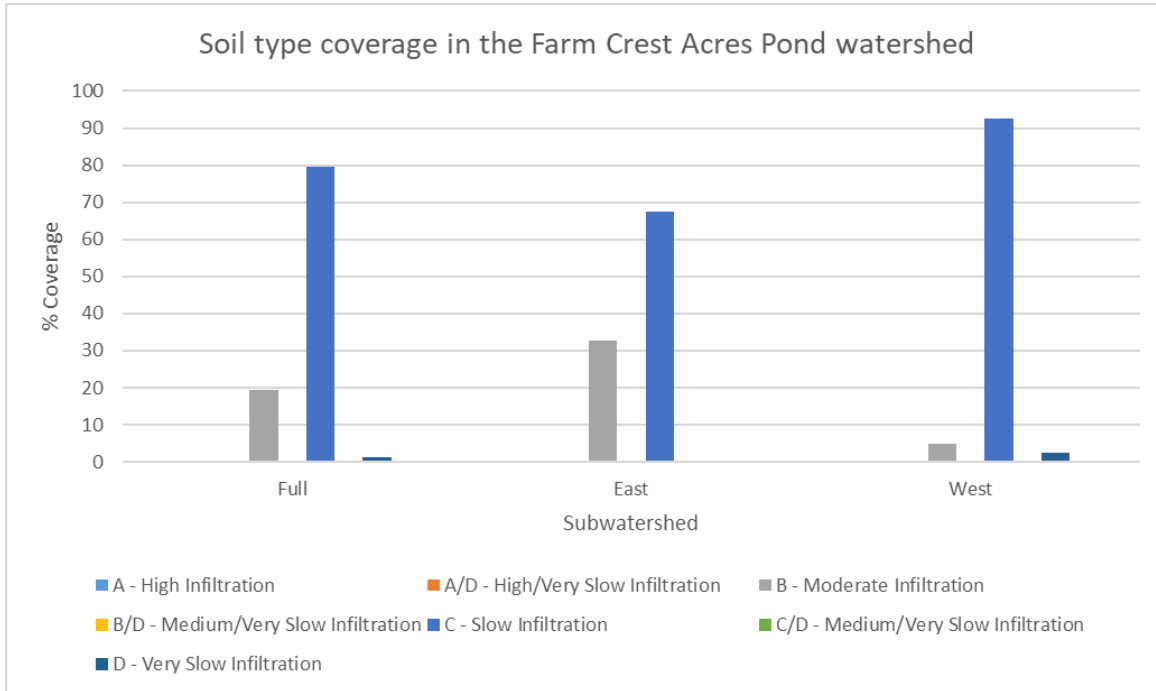
**Figure 15. Percent coverage of Farm Crest Acres Watershed and subwatersheds by different hydrologic soil groups**

The full Farm Crest Acres Pond watershed largely is modeled to consist of soil group “C – Slow Infiltration”, with approximately 20% coverage with group “B – Moderate Infiltration” and a small percentage containing group “D – Very Slow Infiltration”. The West subwatershed features the greatest percentage of lower-infiltrating soil groups.

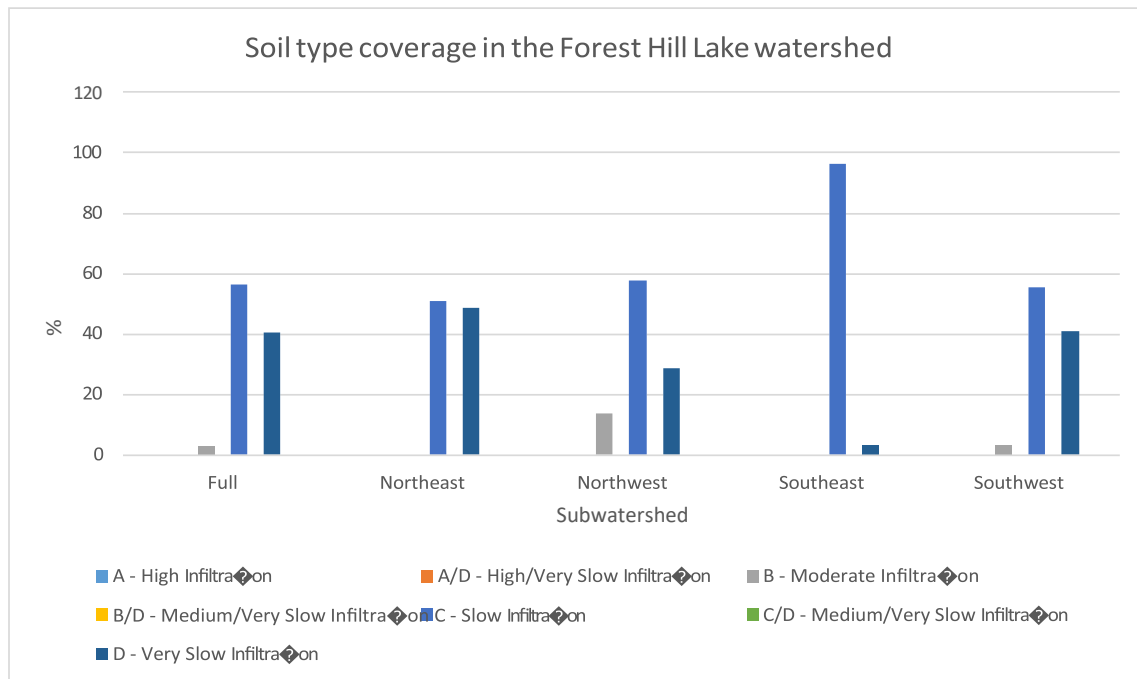
**Figure 20. Percent coverage of Forest Hill Lake's watershed and subwatersheds by different hydrologic soil groups.**

Soils in Forest Hill Lake's watershed consist largely of type C and type D, both of which are slow-infiltrating and prone to runoff. The Northeastern subwatershed in particular yields the highest amount of type D soils – “very slow infiltration”. The two western subwatersheds, however, feature a small amount of type B (“moderate infiltration”) soils, as these subwatersheds have a higher percentage of forested land. The average percent slopes of each subwatershed do not feature a wide variation, although the Northeast subwatershed does feature a notably

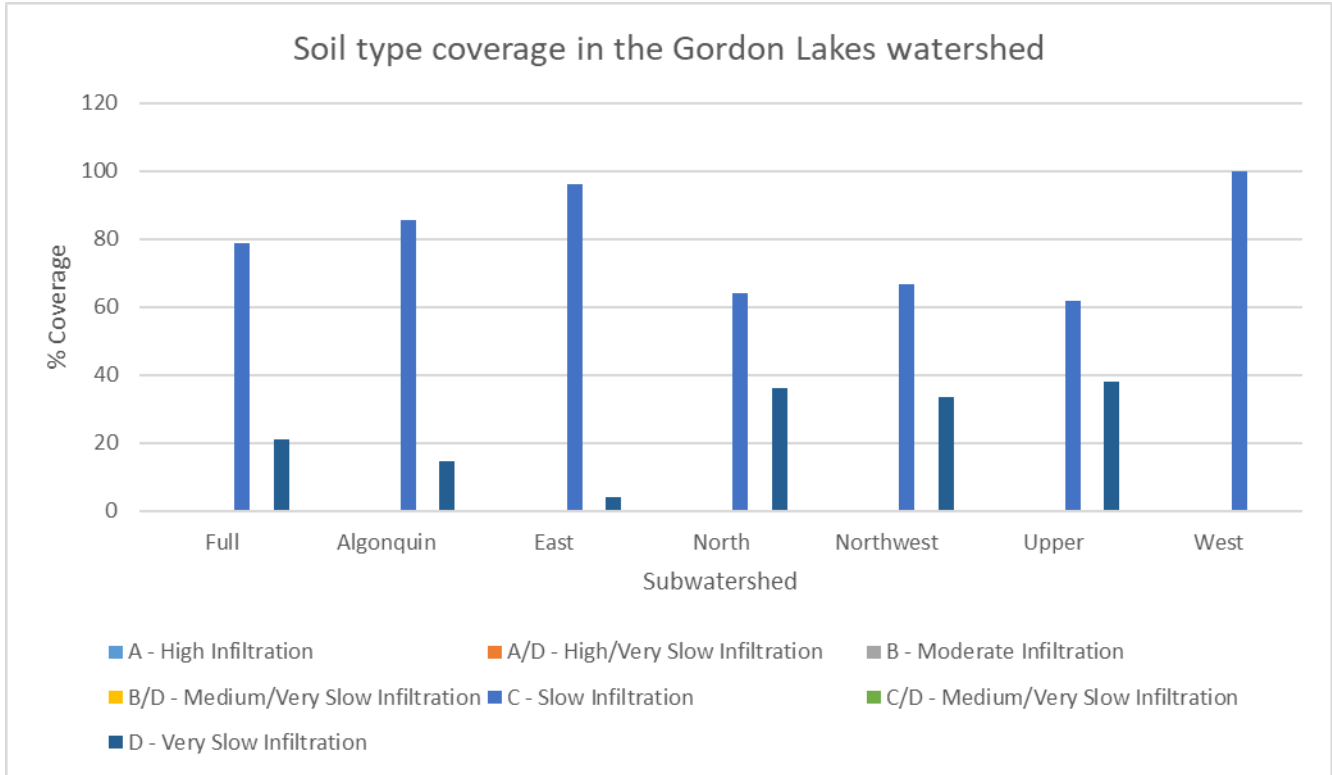
Figure 25. Percent coverage of Gordon Lakes watershed and subwatersheds by different hydrologic soil groups.

The Gordon Lakes Watershed largely consists of the soil-type C – “slow infiltration”, although a significant portion also contains soil-type D – “very slow infiltration”. This slower infiltration group is most prevalent in the North, Northwest, and Upper subwatersheds. The percent slope in the full Gordon Lakes watershed averages approximately 11%, while the maximum slope measures approximately 36%, occurring in the Algonquin subwatershed.

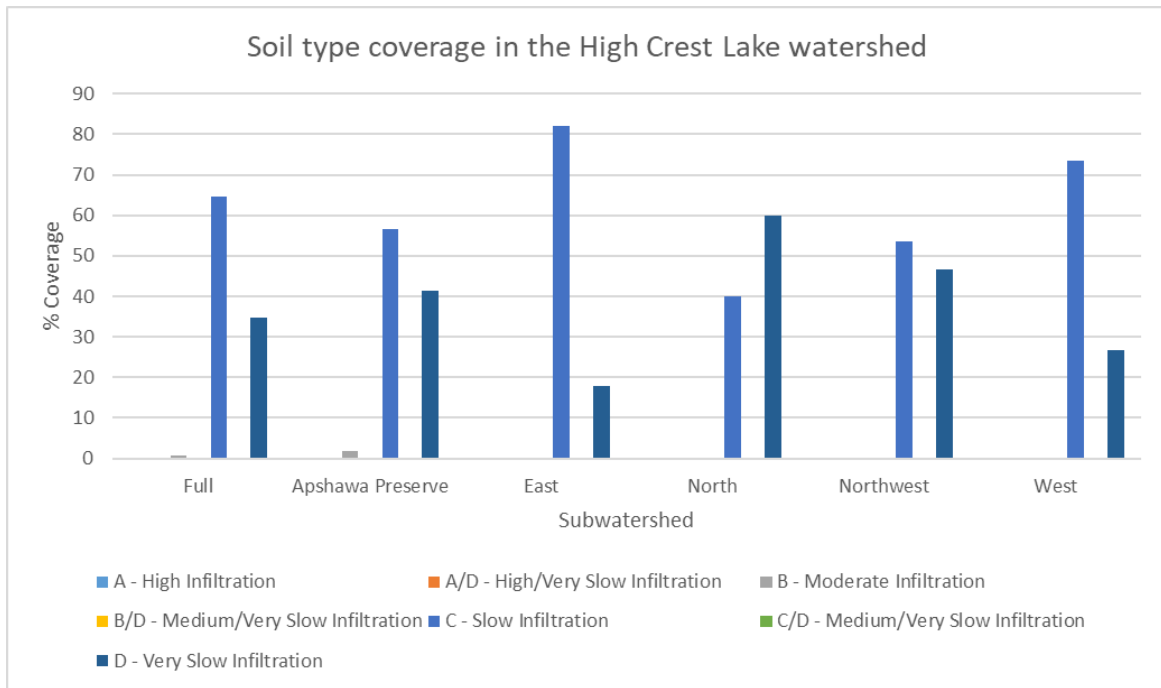
Figure 29. Percent coverage of High Crest watershed and subwatersheds by different hydrologic soil groups.

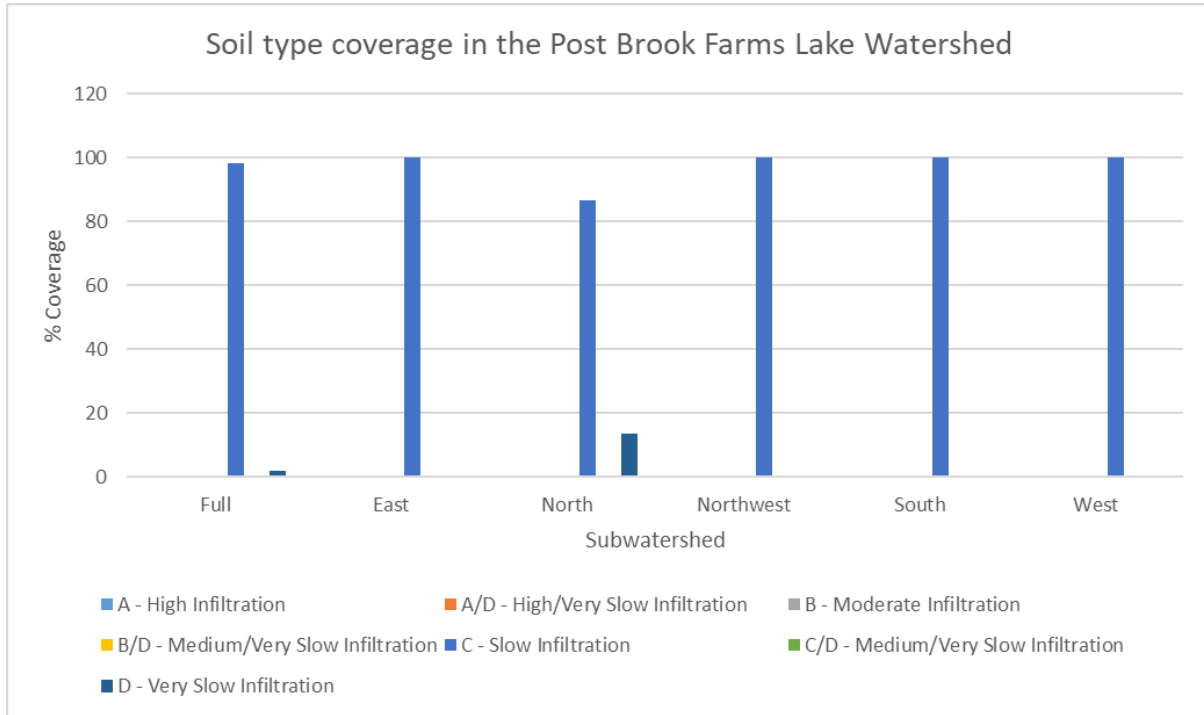
**Figure 78. Percent coverage of Post Brook Farms Lake’s watershed and subwatersheds by different hydrologic soil groups.**

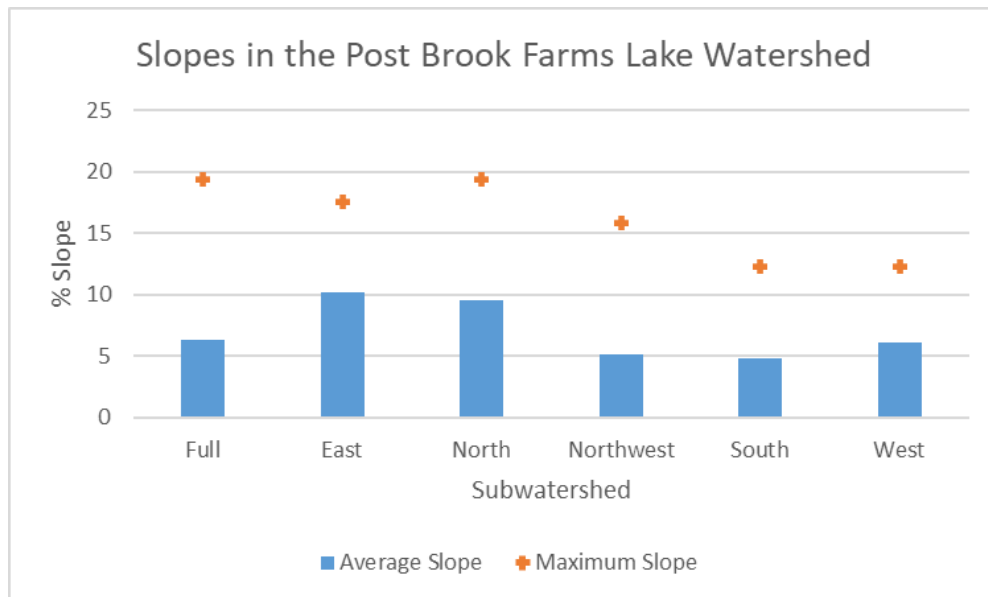
**Figure 79. Variation in average and maximum percent slope between subwatersheds in the Post Brook Farms Lake watershed.**

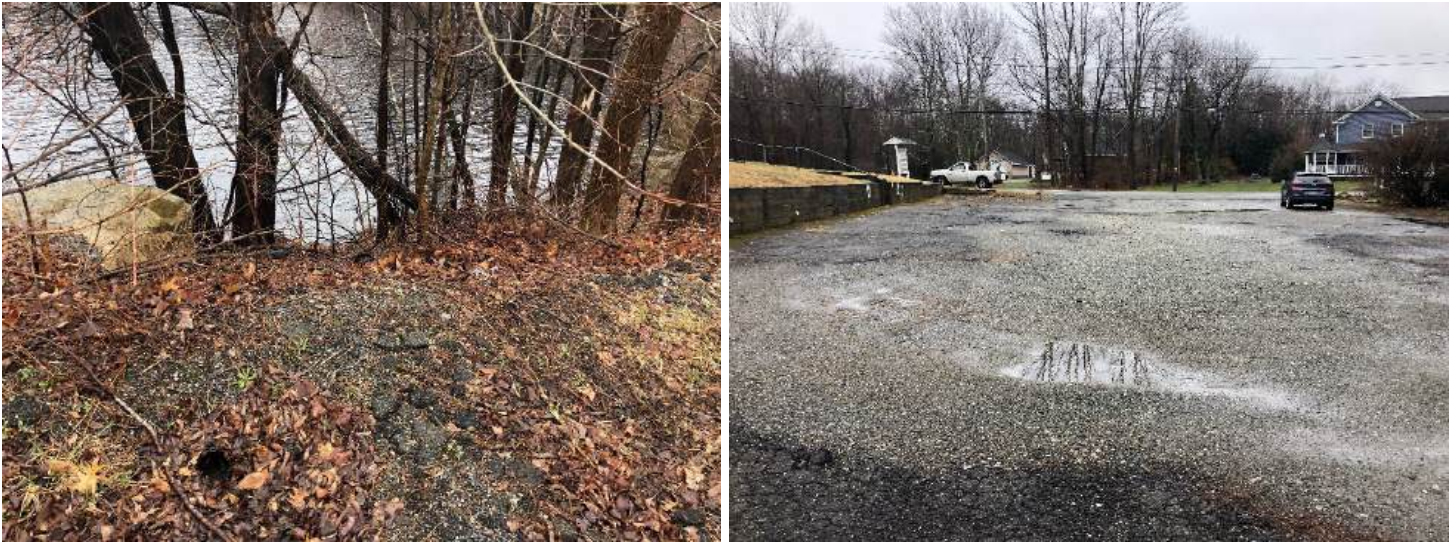
*Photos 14-15. Gravel parking lot at the Greenwood Baptist Church*

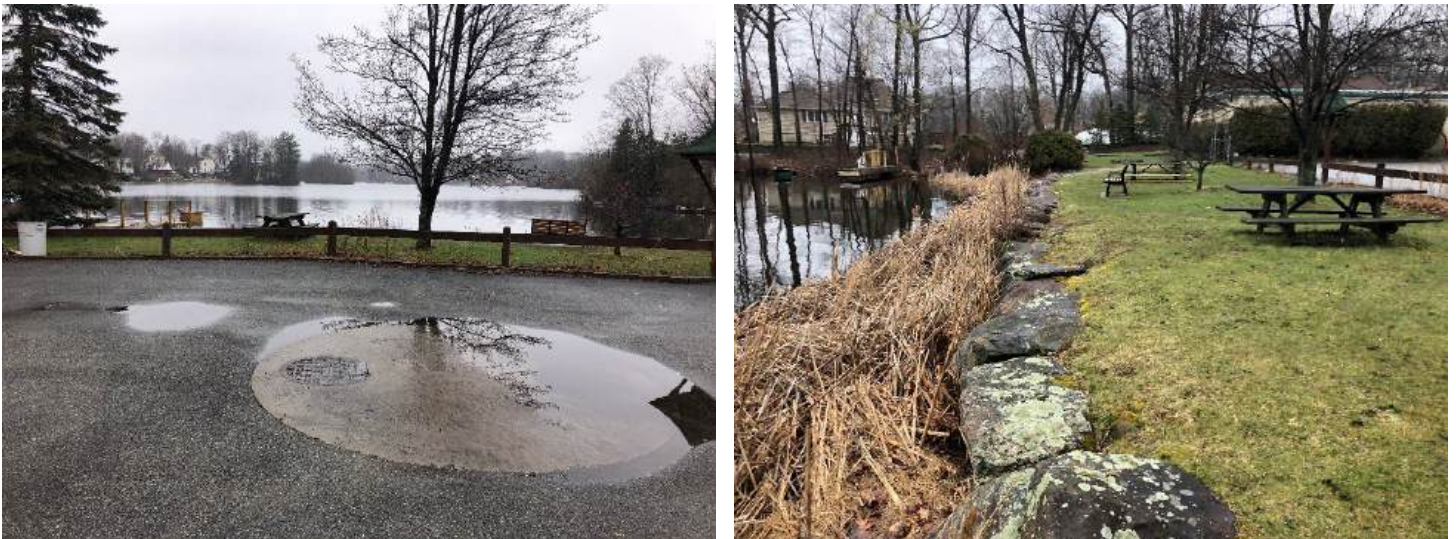
Photos 20-21. Parking lot and grass area on North Lake Shore Drive

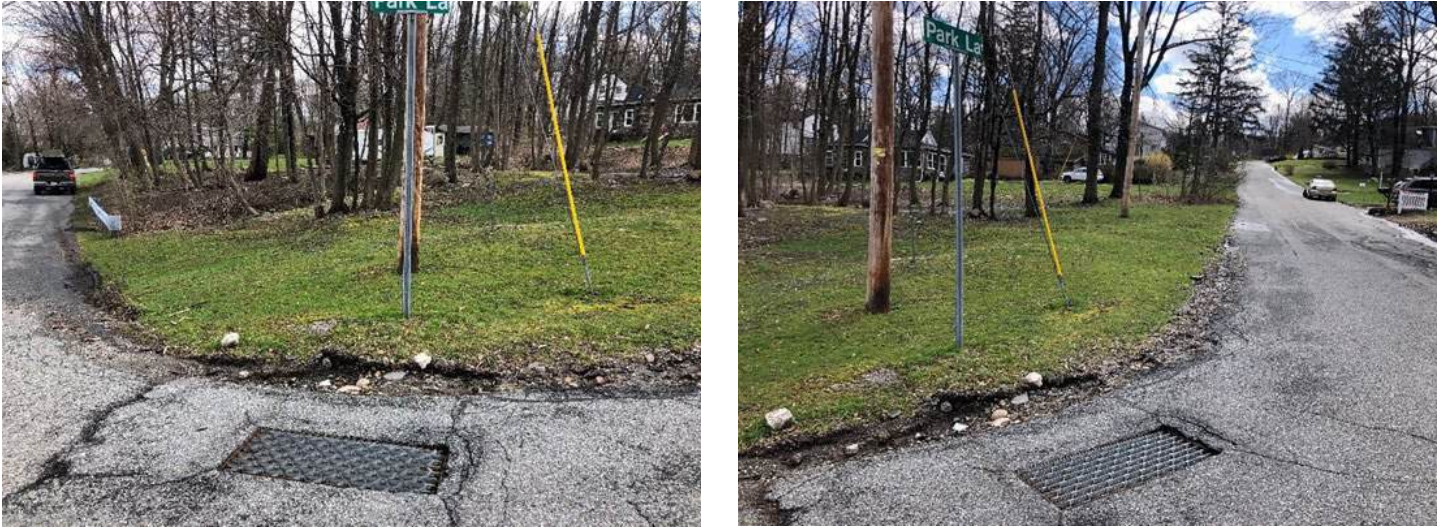
*Photos 40-41. Catch basin on the corner of Pinecliff Lake Drive and Park Lane*

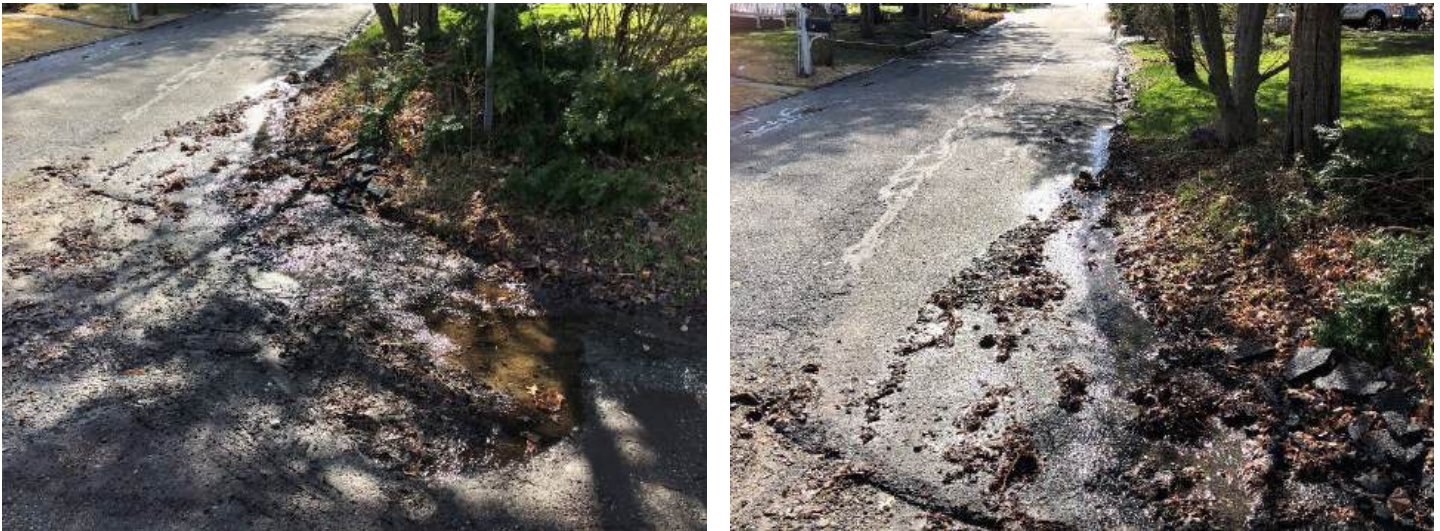
*Photos 46-47. Filled in catch basin and erosion along Arcata Lane*

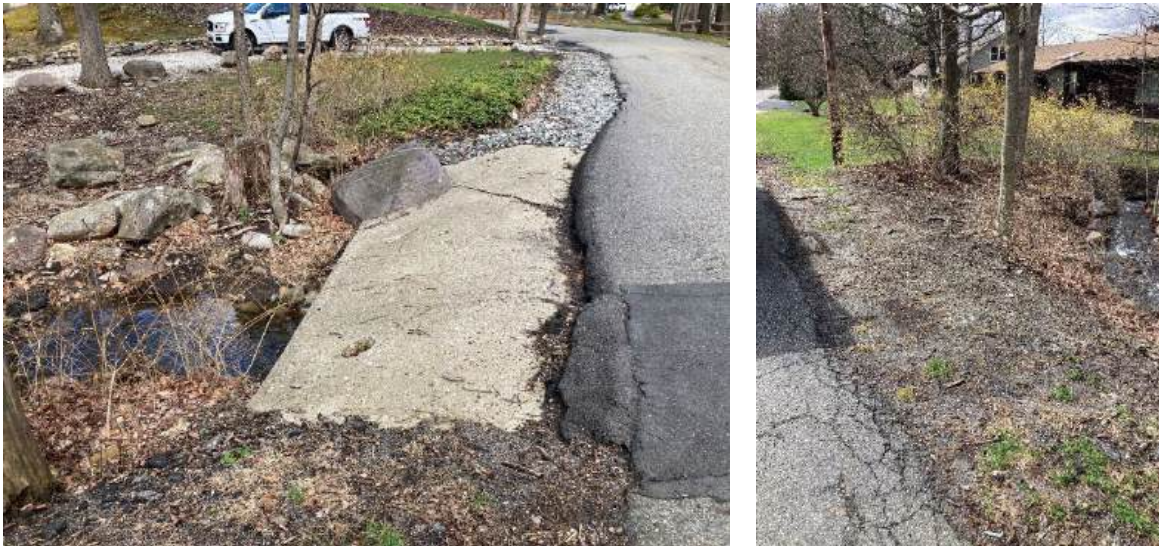
*Photos 51-52. Stream crossing on the west side of Kitchell Lake Drive East*

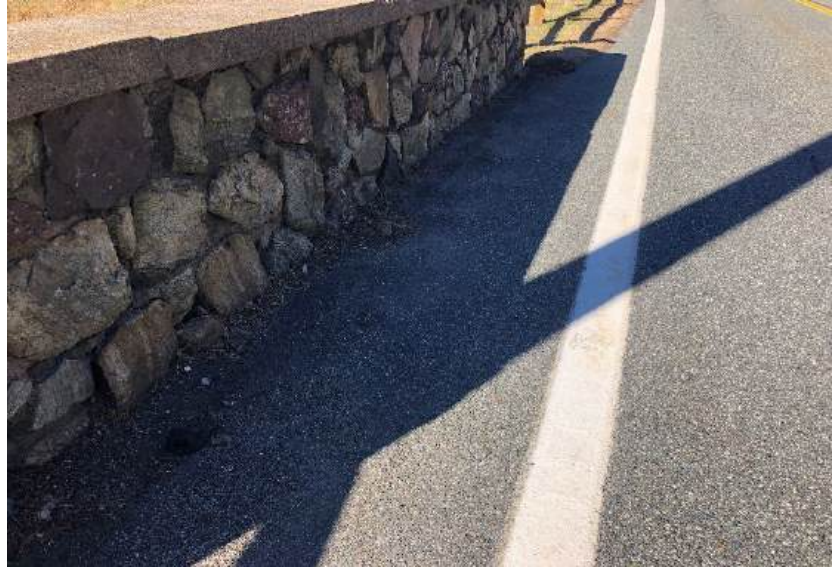
*Photos 69-70. Erosion at culvert headwall and impoundment bank (left) and accumulation of sediment upstream of scour condition on west side of Otterhole Road*

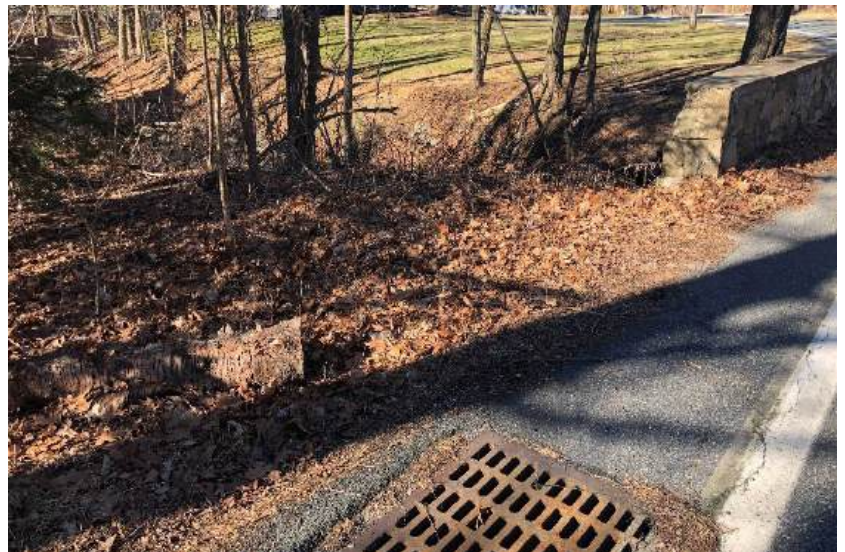
*Photos 71-72. Discharge pipe from inlets up slope draining into stream (Left) Headwall and inlet on west side of Otterhole Road with debris and erosive banks and erosion at banks on residential properties*

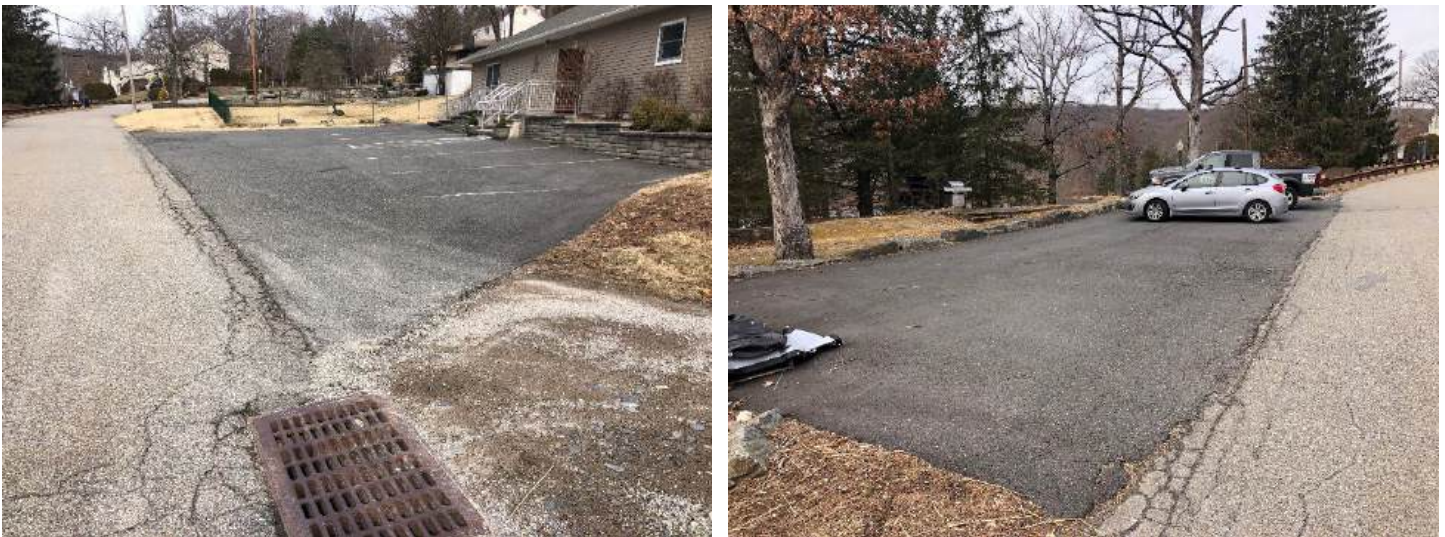
*Photos 96-97. Asphalt parking lots on both sides of Forest Hills Drive*

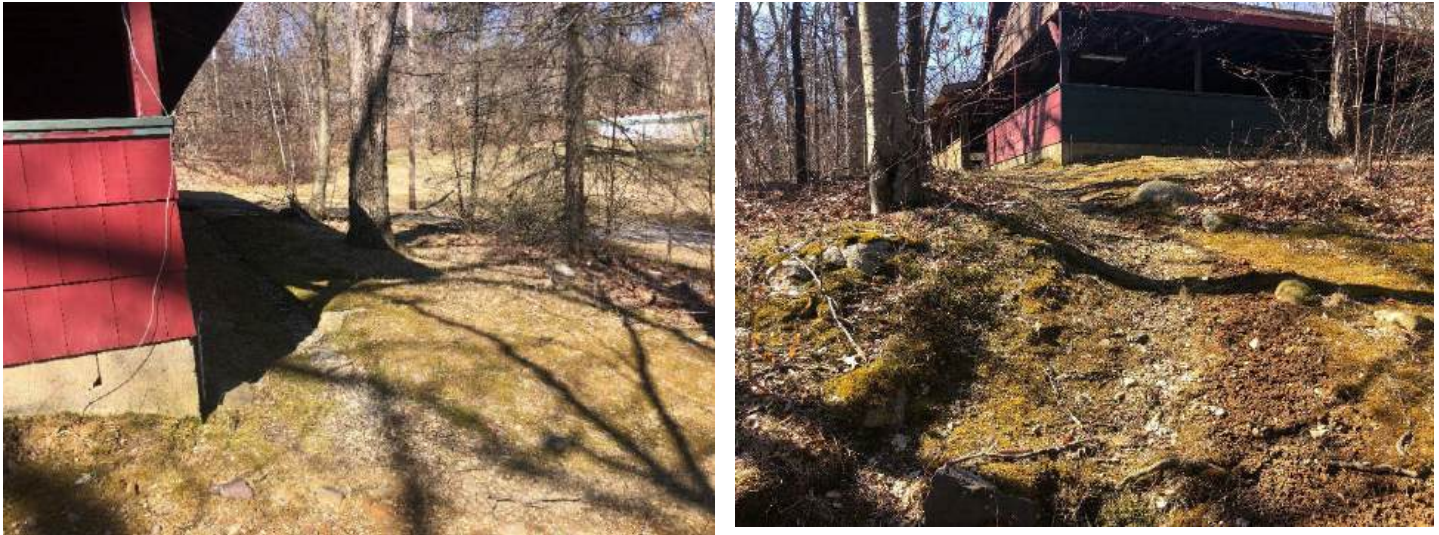
*Photos 104-105. Erosion along the outside of the pavilion from the roof runoff*

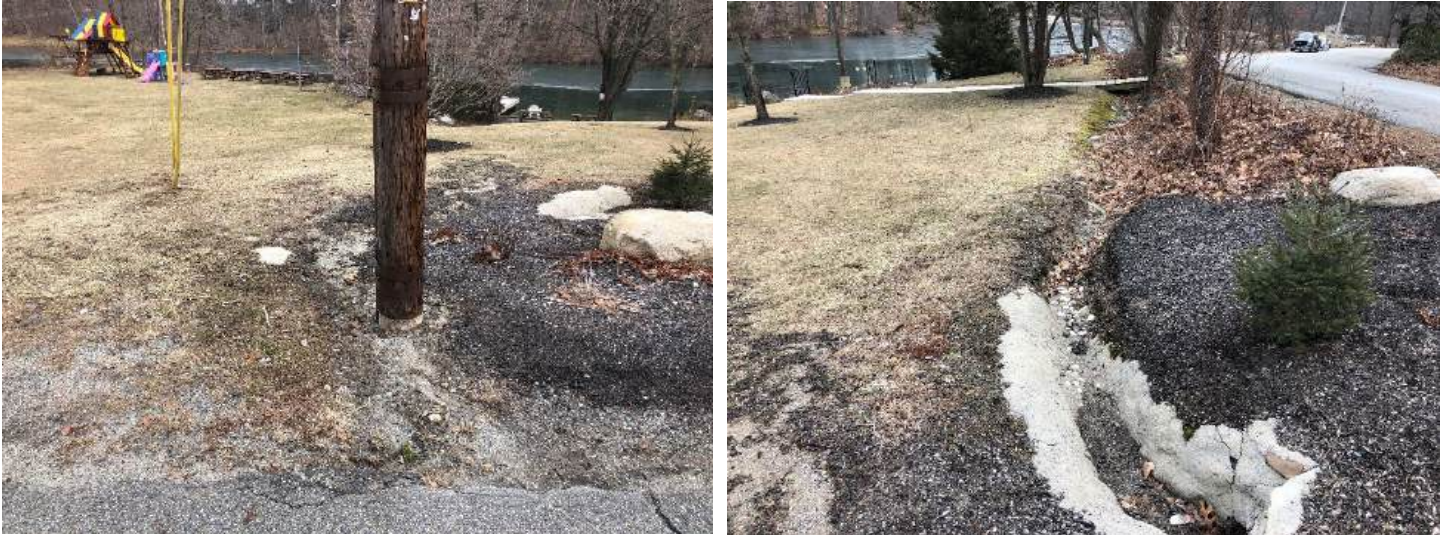
*Photos 127-128. Current conditions along Doremus Road*

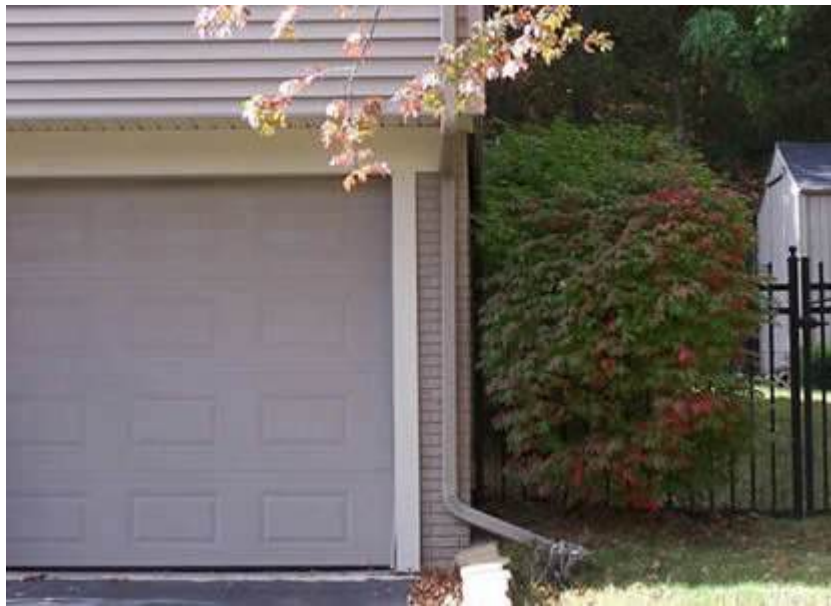
*Photo 133. Downspout Disconnection, Source: USEPA*

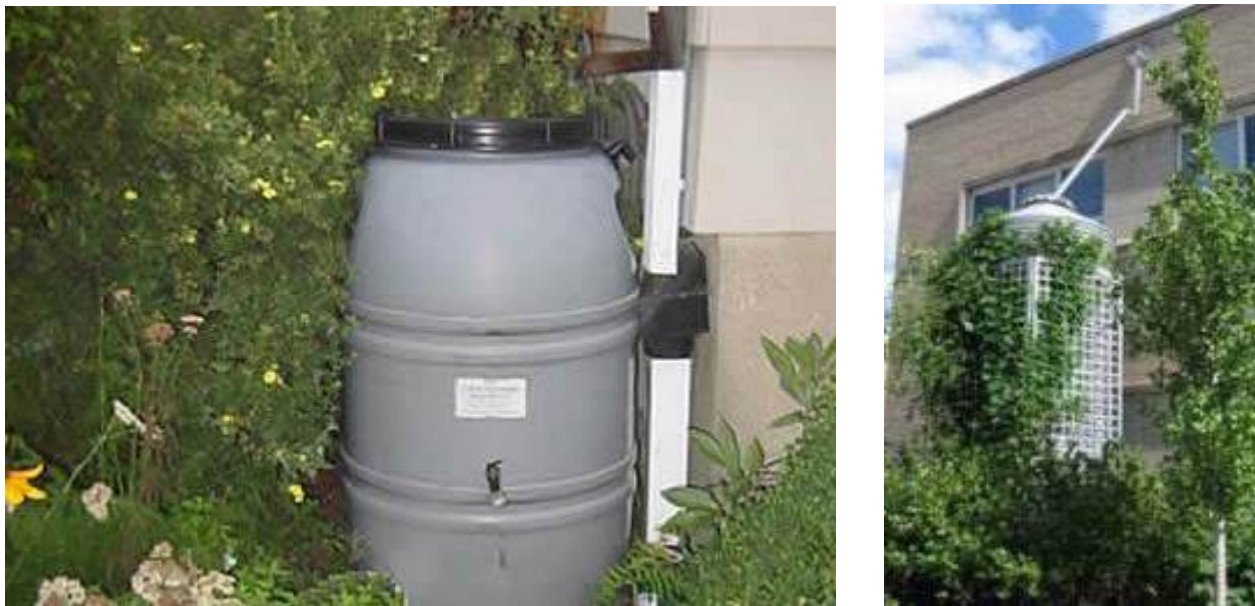
Photo 134-135. Rain barrel (left) and cistern (right), Sources: CTDEEP (left) and USEPA (right)
